TECHNICAL MEMORANDUM #3

Gilliam County Transportation System Plan Update

Existing Conditions Inventory & Analysis

Date: November 27, 2014 Project #: 17679

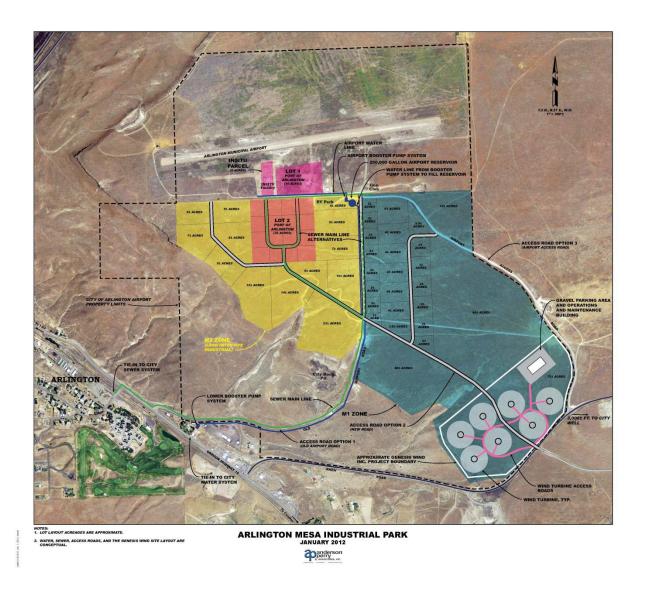
Exhibit 1. Arlington Mesa Industrial Park Plan

The Airport is adjacent to the Arlington Mesa Industrial Park which has 30 available acres zoned M1 and M2 (industrial) for airport development, as shown in Exhibit 1. The Airport is located in the Enterprise Zone within the City Limits of Arlington and maintains an Airport Development (AD) overlay zone.

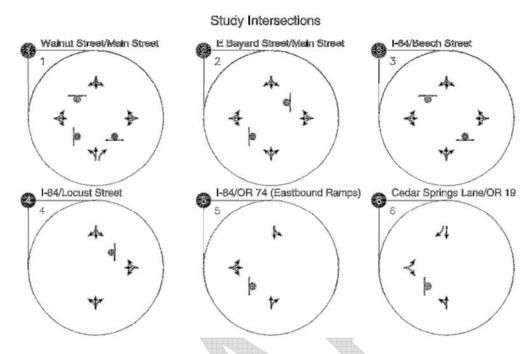
Figure 3-4. Study Intersection Existing Lane Configurations and Control

Table 3 summarizes the characteristics of the state highways in the County, and Figure 3-4 summarizes the characteristics of the study intersections. Each of the study intersections is under ODOT's jurisdiction. All of the study intersections are unsignalized; no signalized intersections are present within Gilliam County.

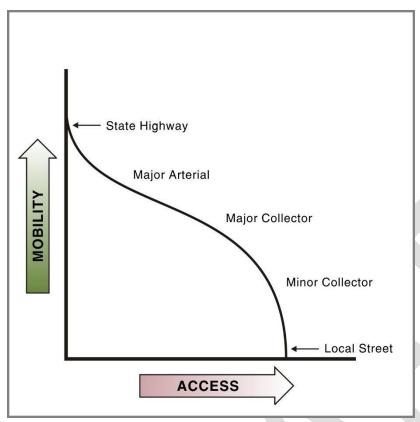
Exhibit 2. Relationship between Access, Mobility, and Functional Classification

Access management strategies and implementation require careful consideration to balance access and mobility in a safe and efficient manner. In general, access management is generally more stringent on higher classified roads where mobility is the highest priority. Exhibit 2 illustrates the relationship between access and mobility relative to the street classifications in the Gilliam County area. OR 19 and OR 206 bisect the cities of Arlington and Condon and run through the downtown commercial areas of both cities. Therefore, these facilities must balance carrying through traffic and providing access within the downtown cores.

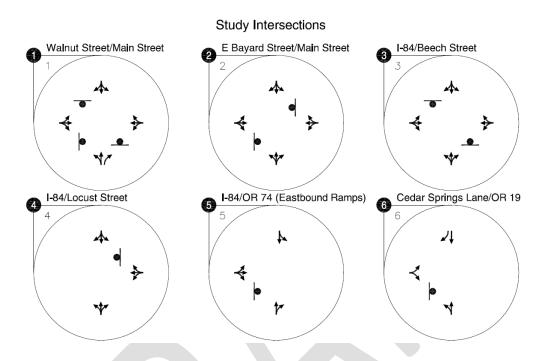
Exhibit 3. Study Intersection Traffic Control and Lane Configurations

As summarized in the Methodology Memo (see *Appendix 3*), traffic volumes were adjusted to reflect seasonal fluctuation in traffic patterns. Exhibit 3 shows the existing intersection traffic control and lane configurations. Exhibit 4 summarizes the existing peak hour traffic volumes after seasonal adjustments were applied and the peak hour time period for each intersection.

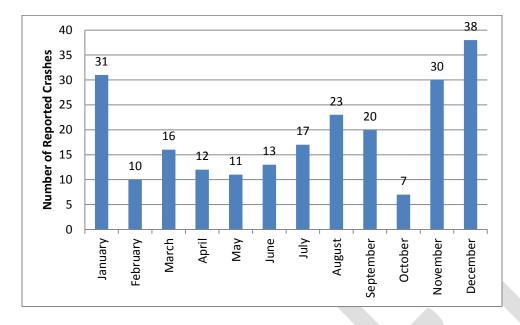
Exhibit 5. Reported Crashes by Month (2009-2013)

Exhibit 5 shows the number of crashes reported by month.

As shown in Exhibit 5, the highest crash frequency occurred from November through January, which typically experience inclement weather conditions producing wet, icy, and/or snowy conditions. Further review of crashes in November, December, and January (99 crashes) indicate that 80% (79 crashes) occurred on roadway surfaces that were wet, icy, or snow-covered. Just over 50% (51 crashes) occurred in dark, dawn, or dusk lighting conditions.
